**Request for Proposal (RFP) for  
Bethlehem Visitors Center**

## ROOF ASSESSMENT LETTER REPORT

**VISITORS CENTER  
2182 MAIN STREET  
BETHLEHEM, NH**

Project #2022-066

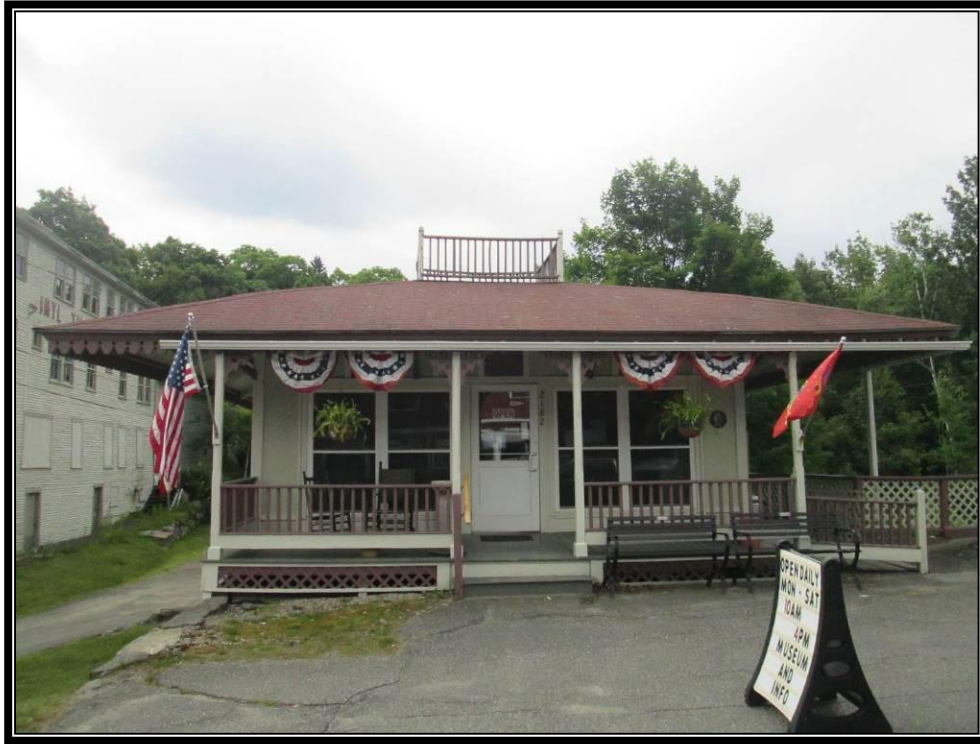
The building is approximately 22 feet by 42 feet with a 6-foot front porch. The building is a single-story structure above grade on the front side facing Main Street (see Photo 1 in Appendix A). A retaining wall parallel to Main Street exposes the walls of the lower level on the sides and back (see Photo 2). The front has a hipped roof while the back of the building has a gable roof (see Photo 3). The roof has 6-foot eave overhangs. The siding of the building is a mix of diagonal boards, clapboards, and T1-11 panels. Reportedly, the front half of the building was constructed in the 1870s and was located across Main Street from its current location. Prior to 1900, the building was moved to its current location. At some point, an addition was constructed on the back of the building, roughly doubling the size of the original structure.

Photo 1: Visitors Center from Main Street.

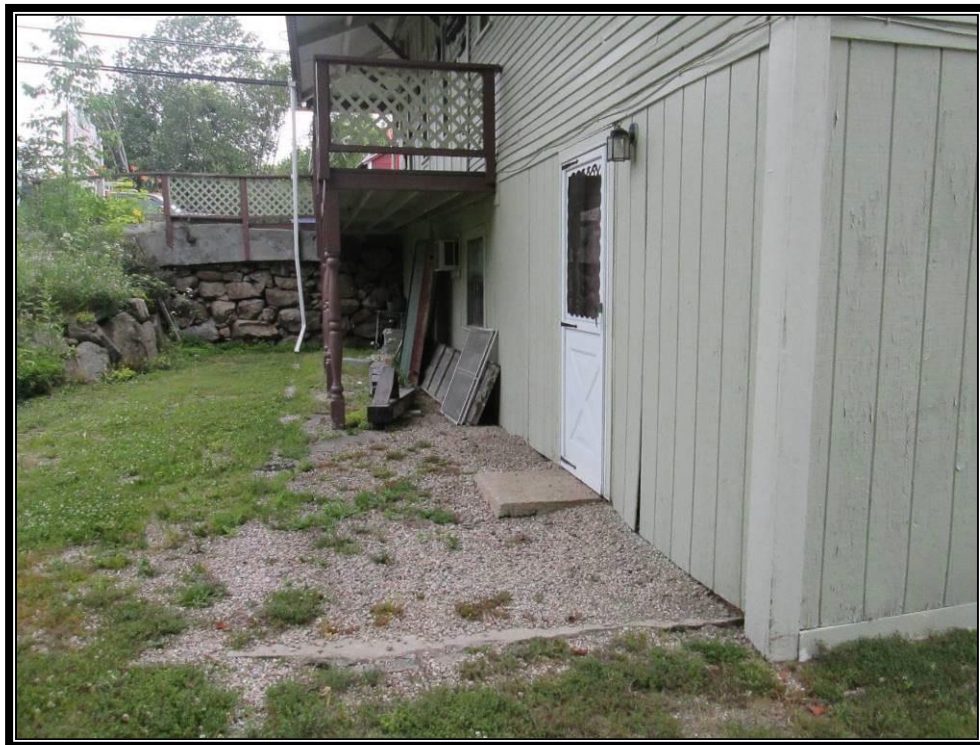
Photo 2: West side of building.

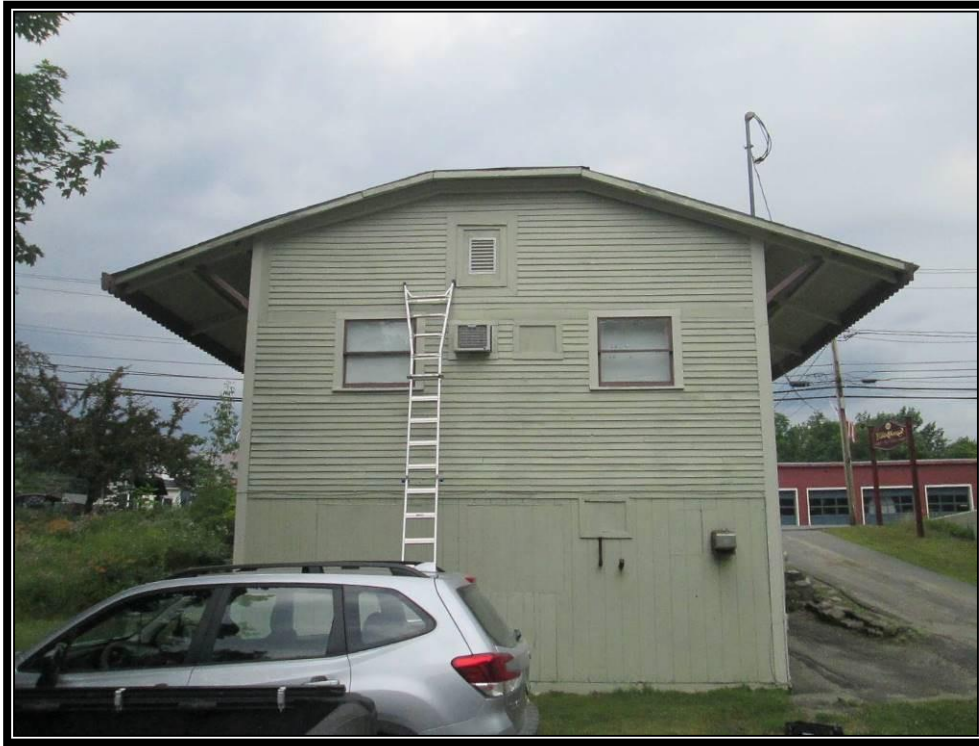
Photo 3: Back of building.

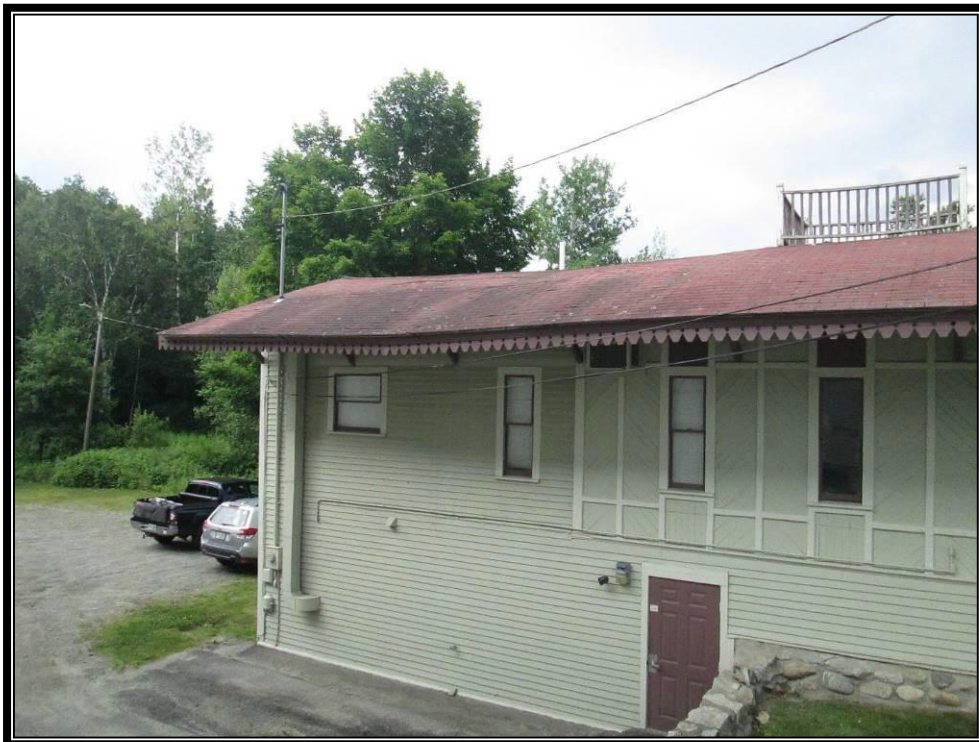
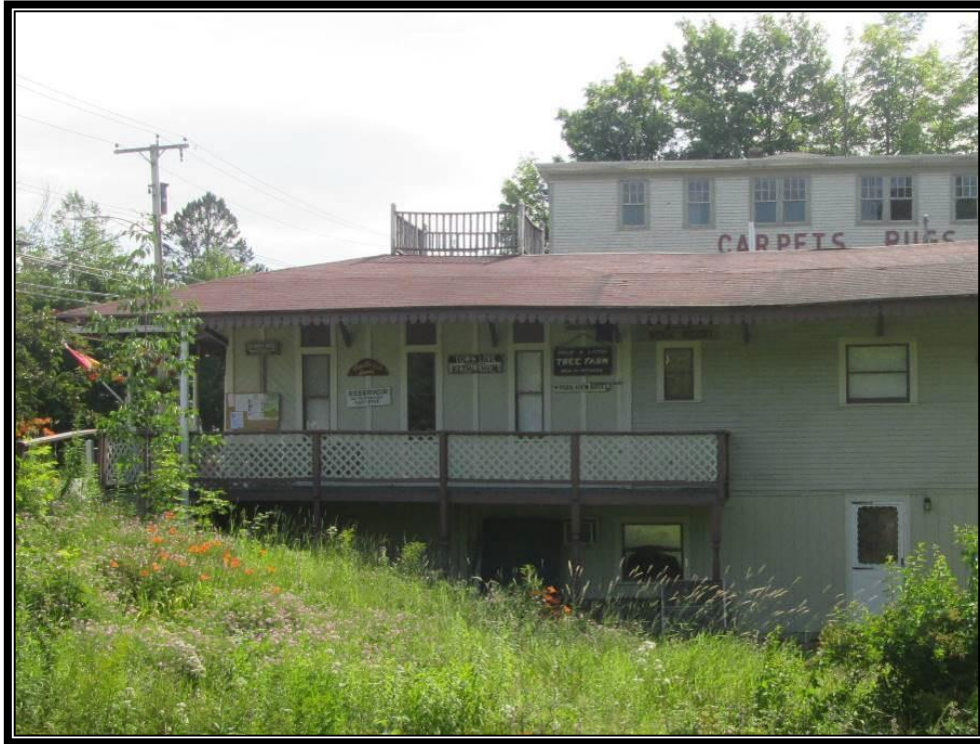
The sloped roof has asphalt shingles while the flat portion of the roof appears to have a rubber membrane. The fields of the roof are uneven with significant settlement (see Photos 4 and 5). There is a visible change in the pitch of the roof at the eaves (see Photo 6). The ridge of the roof slopes down above the north end of the addition and then slopes back up to the south end gable. The eaves also have significant deflection at the north end of the addition. The shingle roofing appears to be in poor condition.

The major deflections and settlement within the roof indicate that there is a failure in the framing. The exterior walls appear to have settled in relation to the interior roof beam supporting the trusses. The settlement has caused deflections and failures of the bottom chords. The settlement in the exterior walls appears due to the extensive rot in the bottom of the wall framing. The grading of the ground around the building allows water to drain to the base of the wall, and potentially under the basement floor framing. We anticipate the sill will require replacement under the entire perimeter of the building. It is also likely removal of more of the siding will expose more rotten framing at the base of the studs and posts. The rotten framing will require replacement.

Photo 4: East side of the roof.  
Note: Siding extends to the ground.

Photo 5: Building from west side.

With the uneven roof framing, failure of truss members, and unknown capacity of the site fabricated trusses, the best remedial action would be to replace the roof framing completely. This can be completed relatively easily because the ceiling is framed two feet below the bottom chord of the truss and construction would have minimal impact on the interior space.

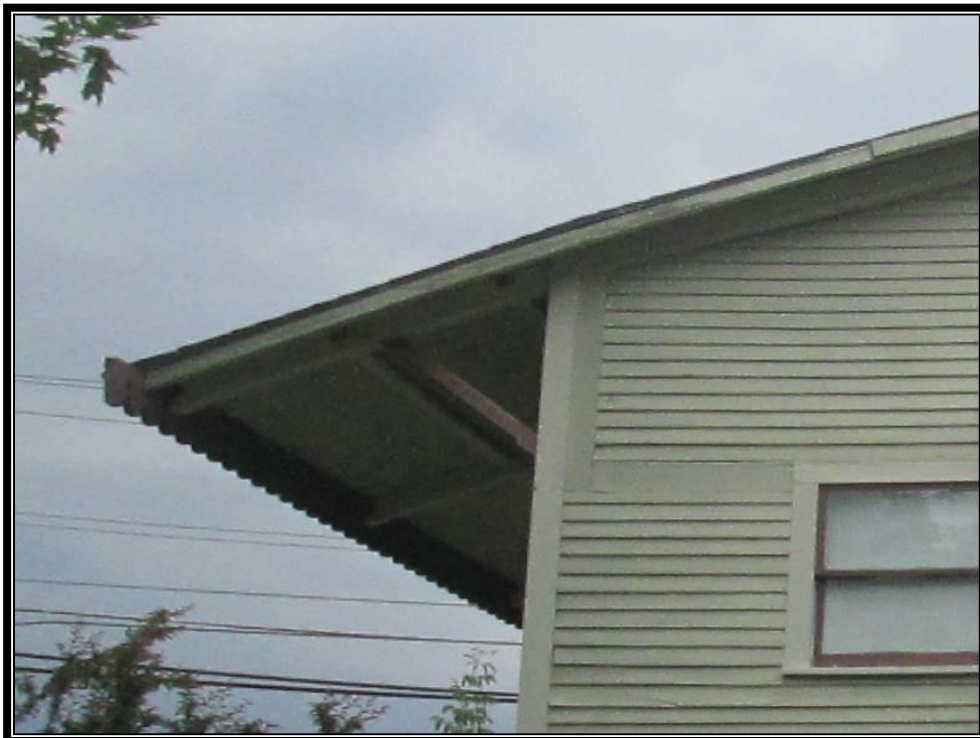
A second roof issue is at the eave framing. There is a clear line in the shingle roofing and a change in slope is visible between the eaves and roof over the interior space. The eaves appear to be significantly undersized for the overhang and this is further confirmed by the deflection of the eaves and cracking of the eave rafters. Reinforcement of the existing eaves would be possible but provided the remainder of the roof will need structural upgrades, replacement of the eave framing is the preferred option.

Photo 6: West eave from the back of the building.

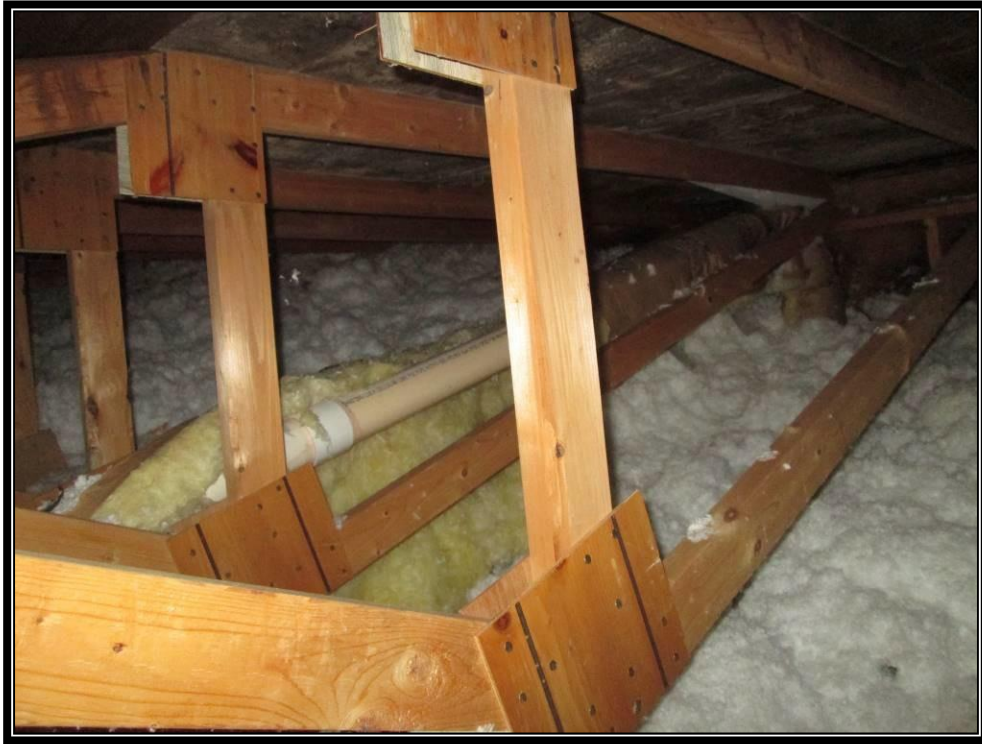
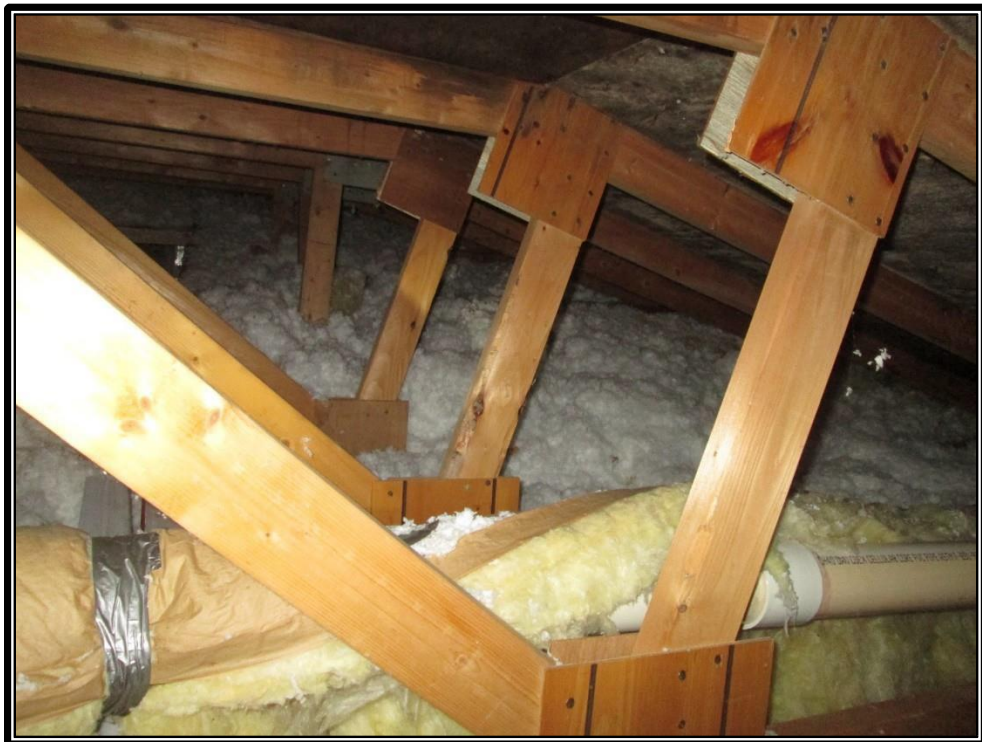
The overframing and addition roofing are constructed of site-fabricated wood trusses consisting of 2x4 lumber, 1/4-inch plywood gussets, and typically 3 roofing nails at each joint (see Photos 7 and 8). The bottom chord of the trusses bears on the east and west walls as well as a (2) 2x10 central beam running north to south. The central beam is slightly higher than the exterior walls and the bottom chord bends down to each exterior wall (see Photo 9). At two locations, the bottom chords are cracked in the area where they pass over the central beam. Otherwise, the trusses appear to be in good condition. The plywood sheathing is stained and mildewed but we did not see any significant leakage to the interior.

Photo 7: Roof trusses at the south end of the roof.

Photo 8: Roof trusses at the south end of the roof.

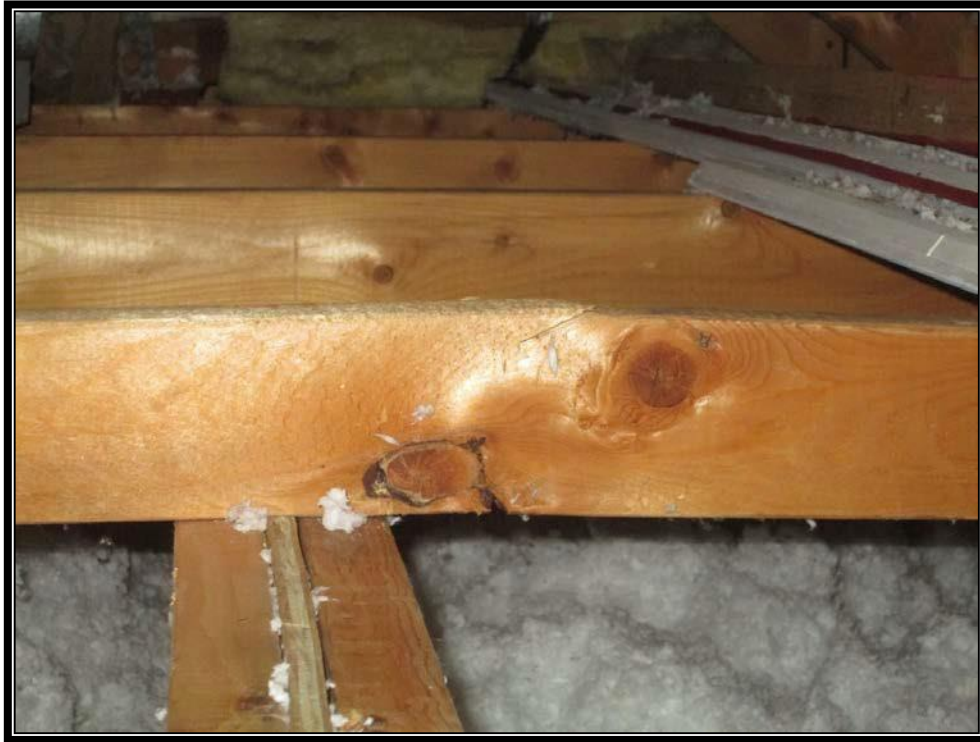
Photo 9: Roof truss bottom chord over central beam.

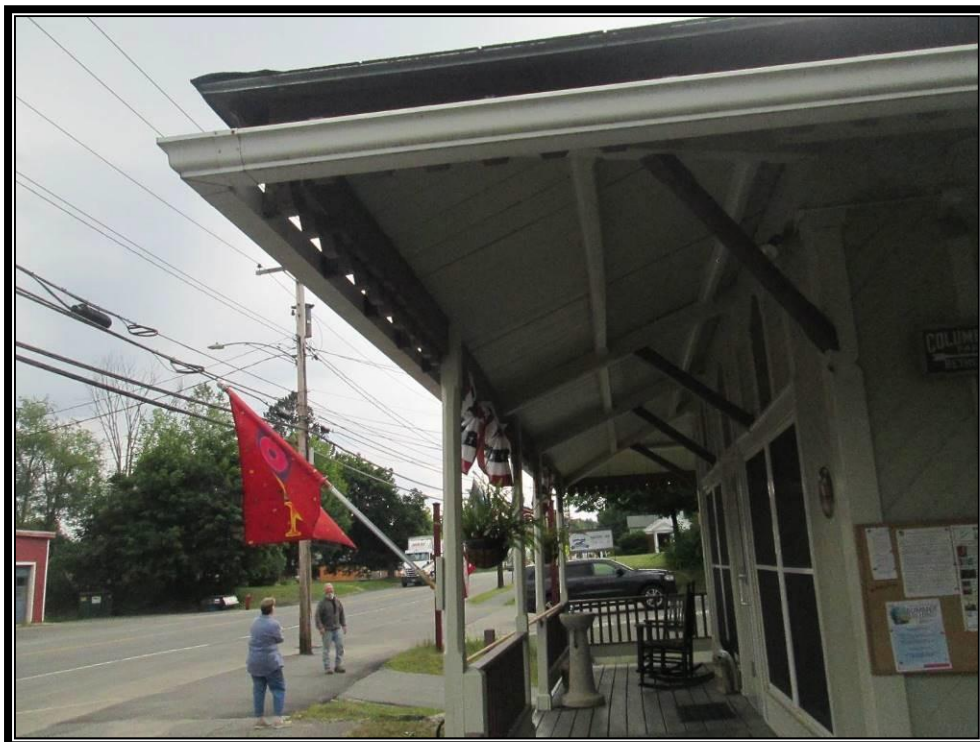
The eave framing generally consists of 4x6 rafters spaced 6 feet on center, with a 2 7/8-inch by 3 3/4-inch knee brace supporting them 30 inches off the wall face (see Photo 10). There are 3-inch by 4-inch purlins spanning between the rafters. The eave rafters are sistered to the sides of the roof trusses over the interior space. Several of the rafters have cracked at the face of the wall (see Photo 11).

Photo 10: Eave framing.

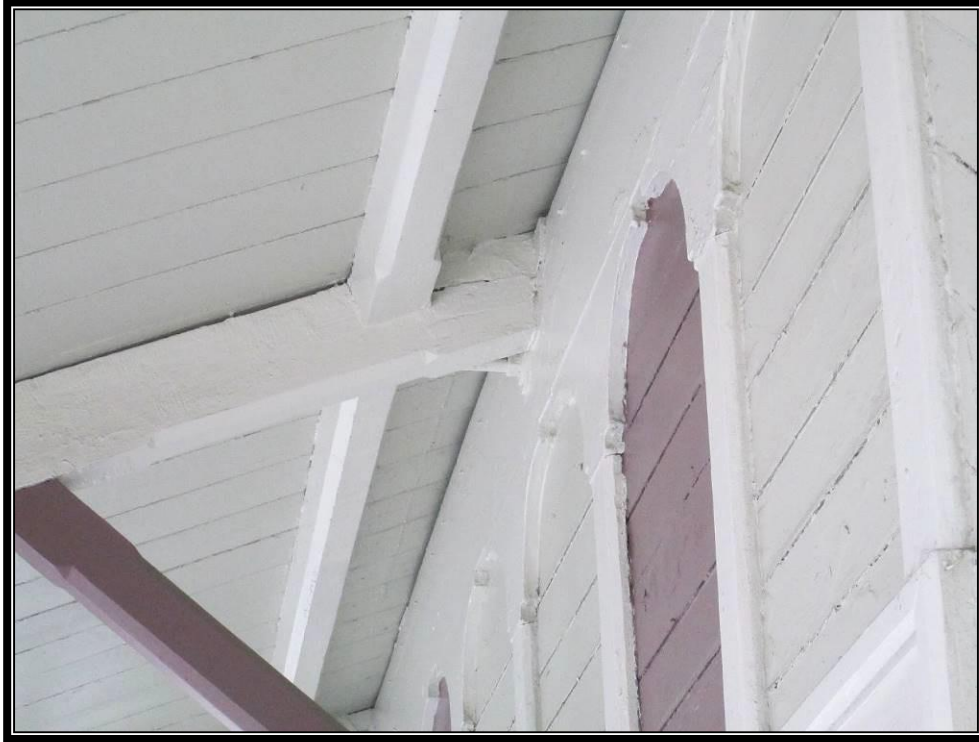
Photo 11: Cracking in the eave rafter at face of building.

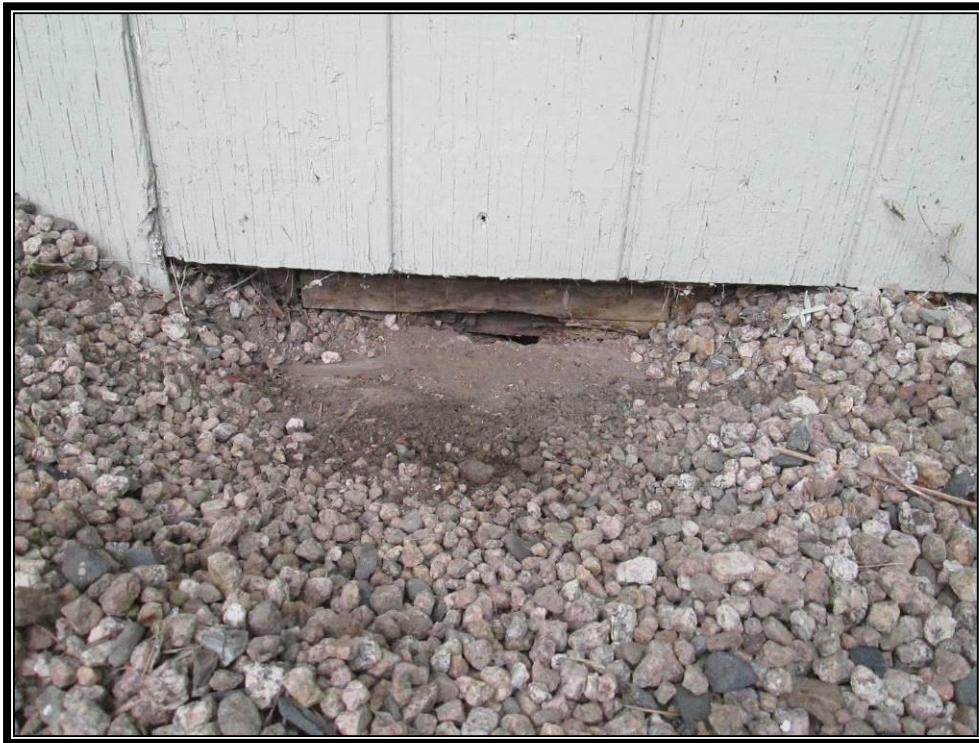
The addition is constructed on top of a concrete slab on grade. It is not clear if there are any foundation walls under the slab. The slab extends several feet beyond the limits of the building to the west side. The finished grade is 2-3 inches higher than the base of the wall framing and the foundation slab (see Photo 12). We removed siding at a location on the west wall and one on the south wall to expose the framing. On the west wall, there is a 2x lumber sill that has almost completely rotted away leaving voids to the slab below (see photo 13). The base of a timber post is also significantly rotten. The wall framing at the south end of the building lands on a timber sill which is roughly half rotted away with voids to the slab below (see Photo 14). There are some concrete and lumber shims between the timber sill and the slab (see Photo 15).

Photo 12: Grade at foundation slab and basement framing.

It is not clear if there are frost wall foundations below the slab. A new foundation would be recommended if there is none. A new foundation is the preferred repair option but is also the most expensive and impactful on the use of the building. A new foundation would have the benefit of protecting the foundation from seasonal movement and could be constructed to raise the framing above ground level separating it from moisture which would then help prevent surface water from draining into the interior of the building.

If there is a foundation already, then drainage at the site should be addressed by lowering the finished grade to below the slab level and grade away from the building. This will direct water away from the framing, preserve the wood, and prevent water from draining into the interior.

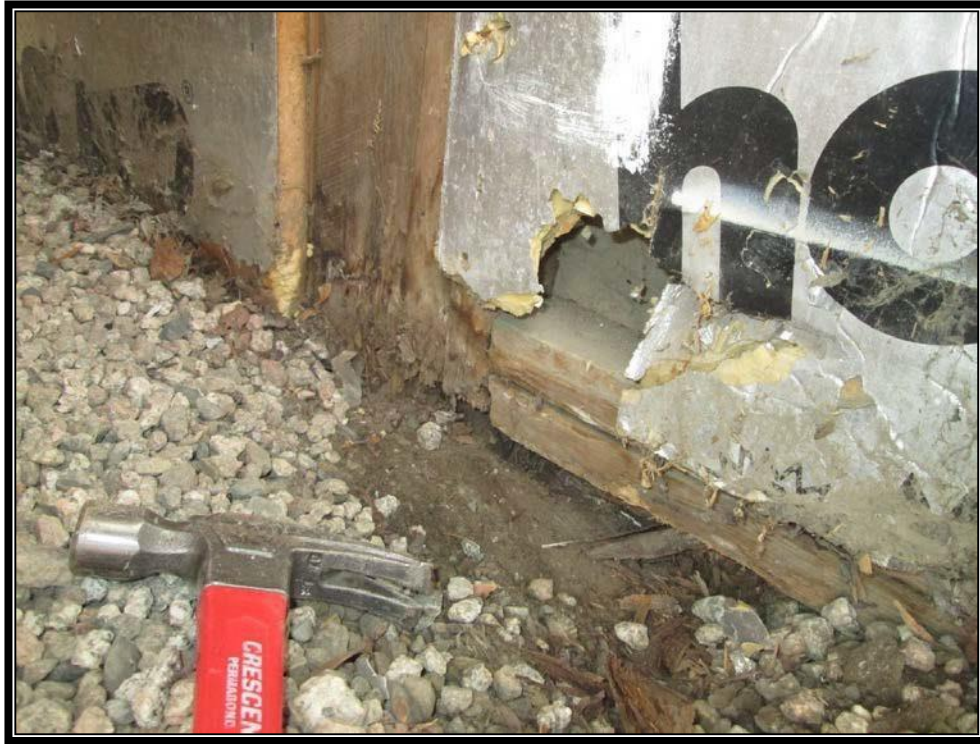
Photo 13: Exposed framing of the west wall at ground level.

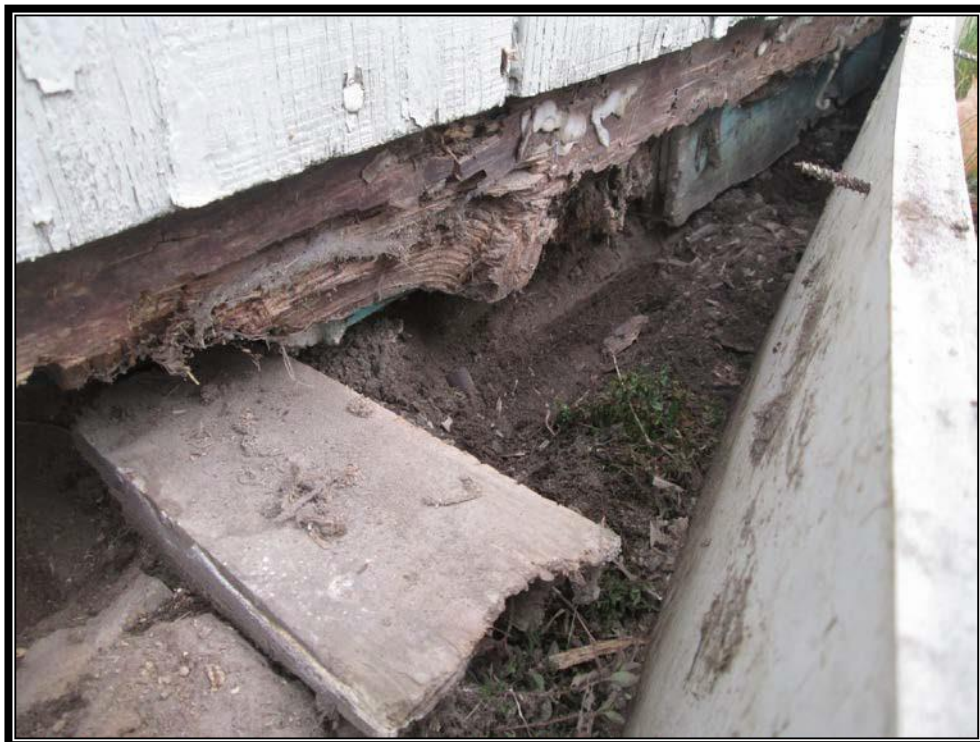
Photo 14: Exposed framing of the south wall at ground level.

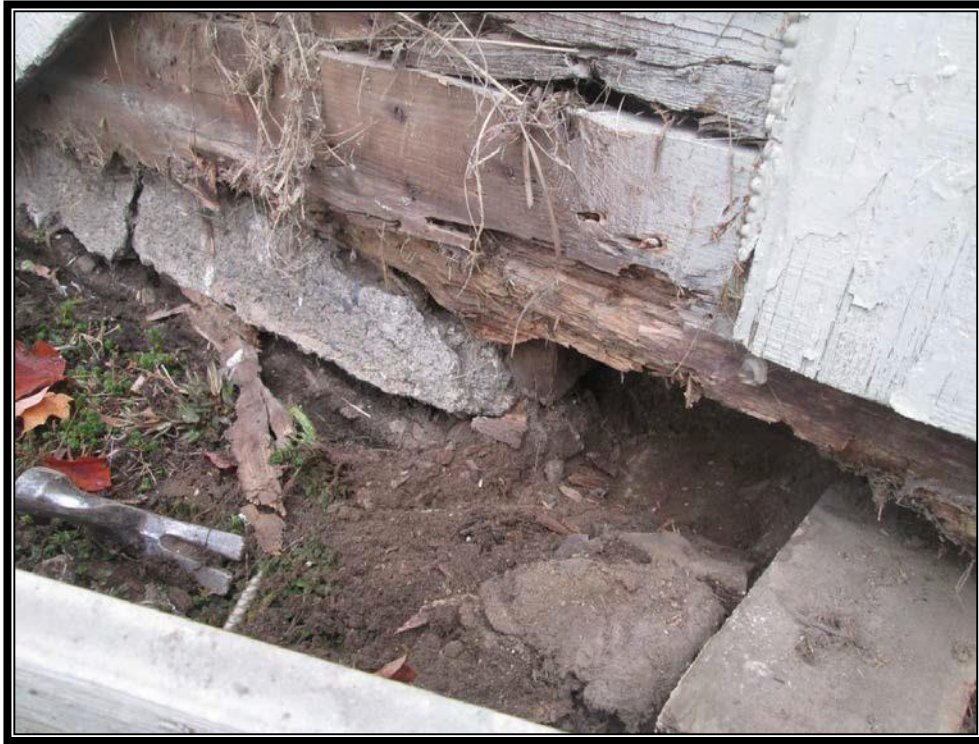
Photo 15: Exposed framing of the south wall at ground level

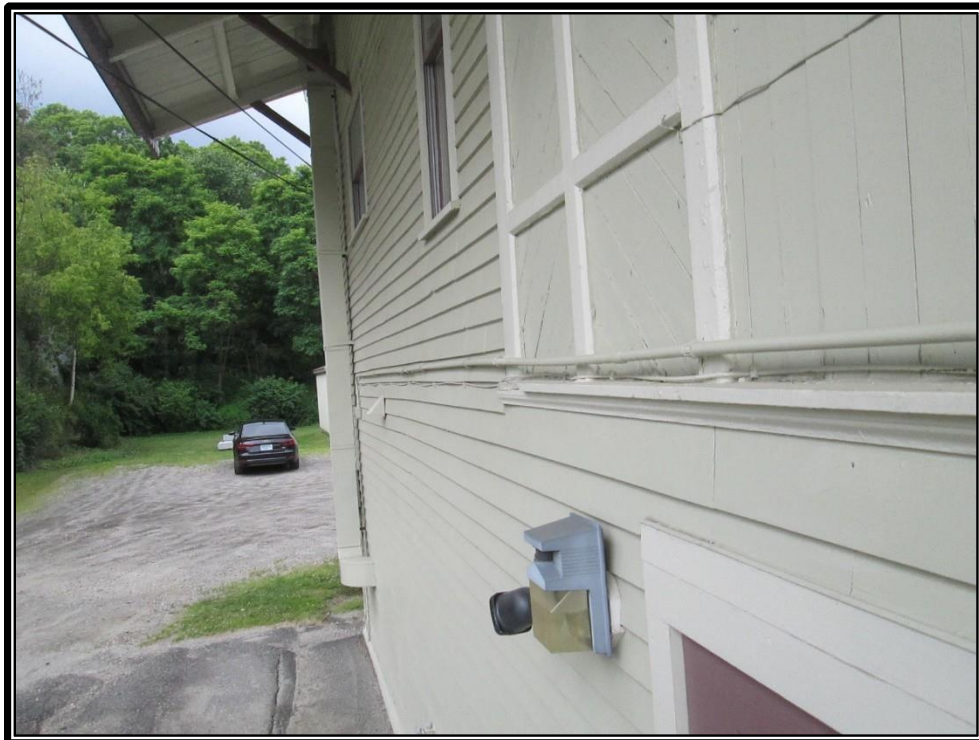
The siding was reportedly repaired and painted 10-15 years ago. On the east side of the building, the siding is in good condition. There may be some settling of the siding at the south end of the building, though very minor (see Photo 16). At the top of the lower level wall on the west side of the addition area, the wall is bulging outwards (see Photos 17 and 18).

Photo 16: Siding on east side of building.

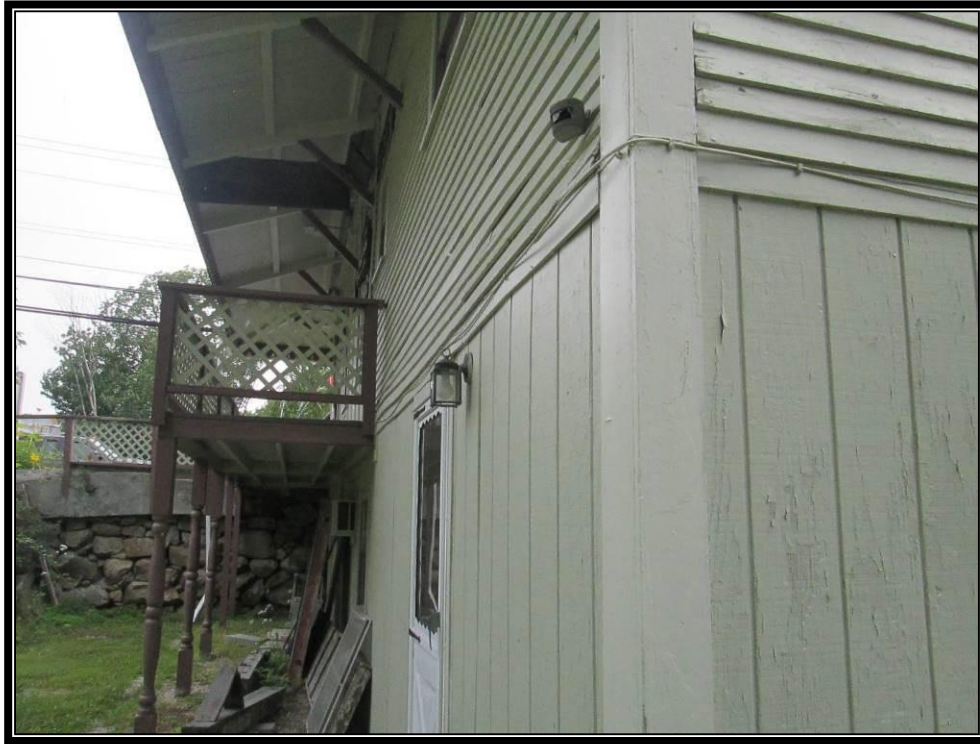
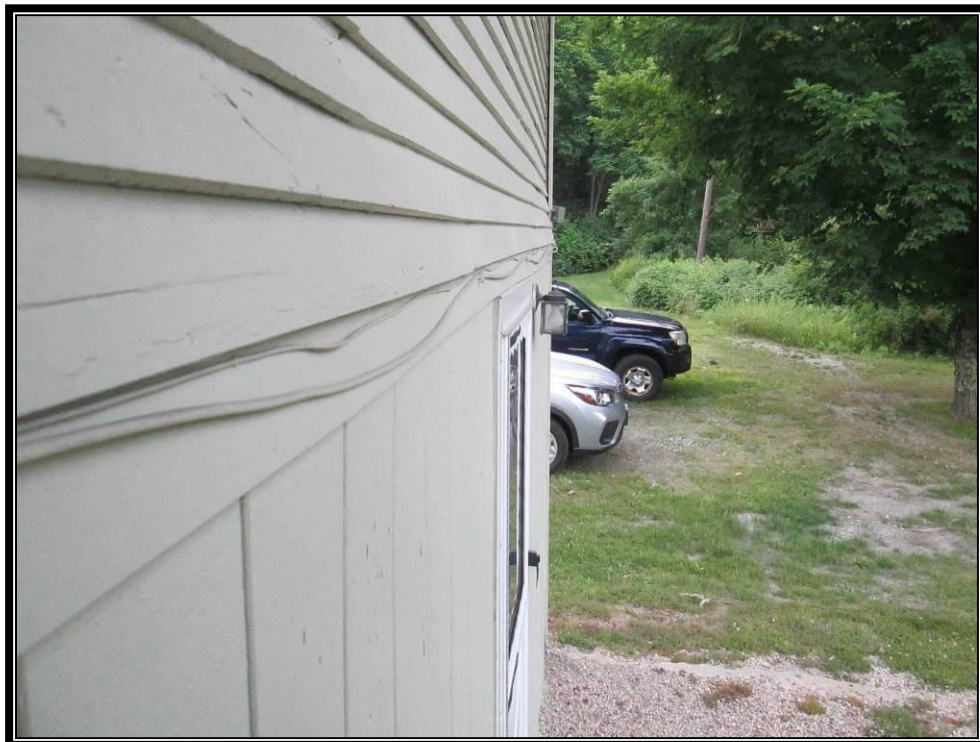
Photo 17: West wall bulge at main floor level.

Photo 18: West wall bulge at main floor level.
